# **Condiciones de seguridad e higiene que prevalecen en la Mina 8 Unidad Pasta de Conchos**

## **Informe**

**Del estudio realizado por el Panel Internacional de  
Expertos en Seguridad en Minas del  
Foro Consultivo Científico y Tecnológico, A.C.**

Octubre 5, 2007

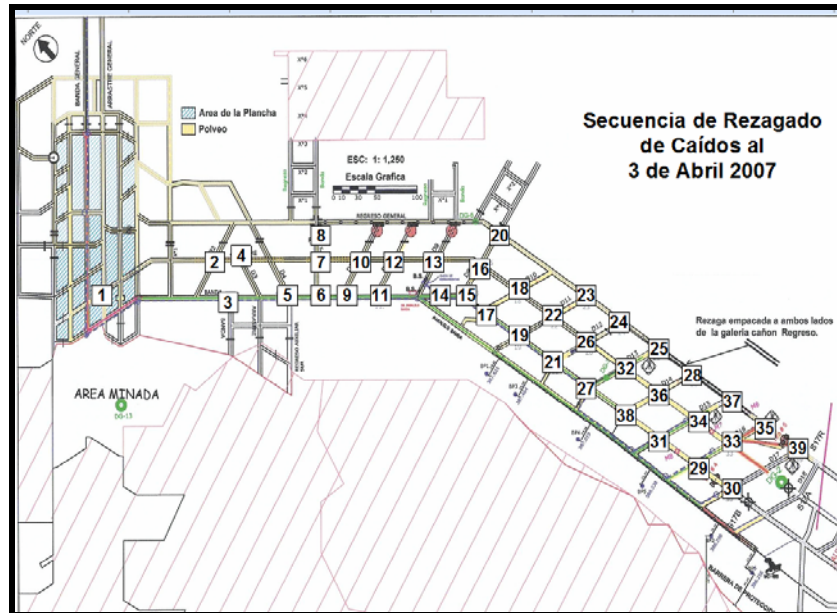
During the rescue and recovery process, 39 major roof falls at intersections, (Figure 2.3) with some of them extending into the entries and the cross-cuts had to be cleared and rehabilitated using manual labor.

Figure 2.3 Locations of major roof falls.

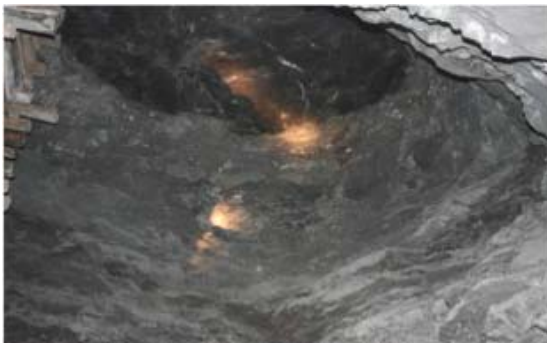
At cross-cut intersections, cavings as great as 13 m high and 15 m wide have been reported (Figure 2.4). The caved areas were rehabilitated with the use of cribbing above timber-steel sets (Figure 2.5). Cribs are designed to support vertical loads, but can collapse when lateral loads are applied. The height of the cribbing used to rehabilitate the caved areas would be extremely unstable in the presence of lateral ground movements (Figure 2.6).

Figure 2.4 Caving at cross-cut 7.

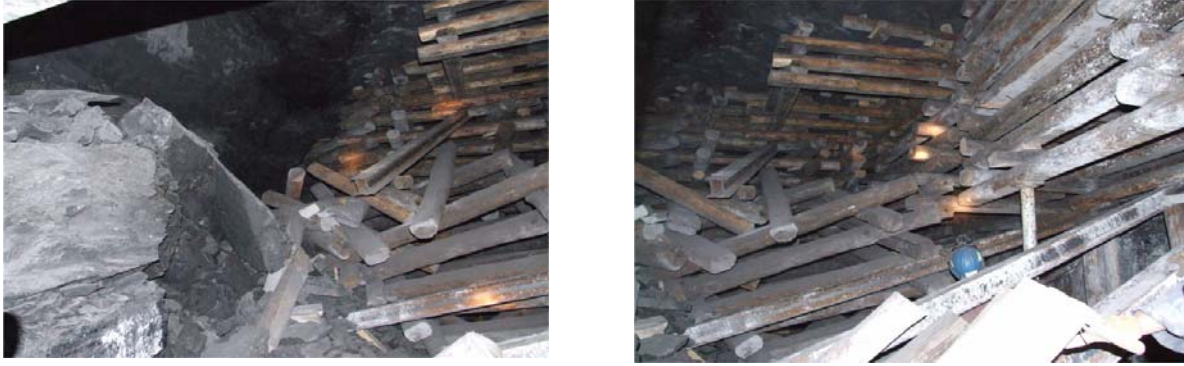
Figure 2.6 Collapsed cribbing at cross-cut 13.

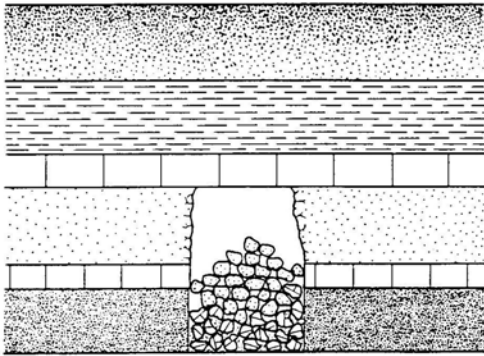
After the initial failure of the immediate roof, caving will continue to propagate upward unless it is arrested by the formation of a new, stable, self supported linear arch, by a more competent roof layer (Figure 2.10), by a vault that has achieved a stable geometry with respect to the stress conditions, or by bulking (swelling) of the roof debris (Figure 2.11) (Karfakis,1987). The failure of the roof toward the surface will be intermittent and progressive. The picture in Figure 2.4 taken at cross-cut 7 shows a caving arrested by a more competent layer.

Figure 2.10 Caving arrested by competent layer

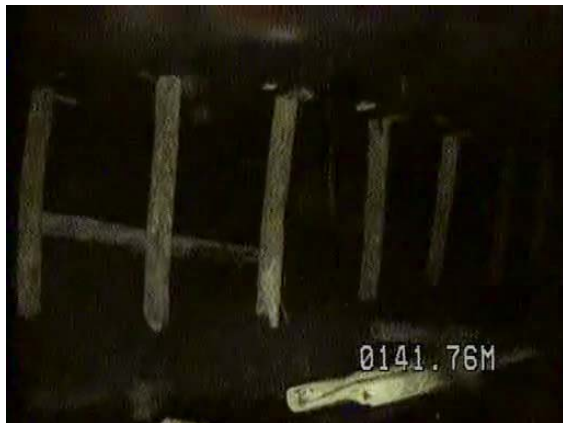
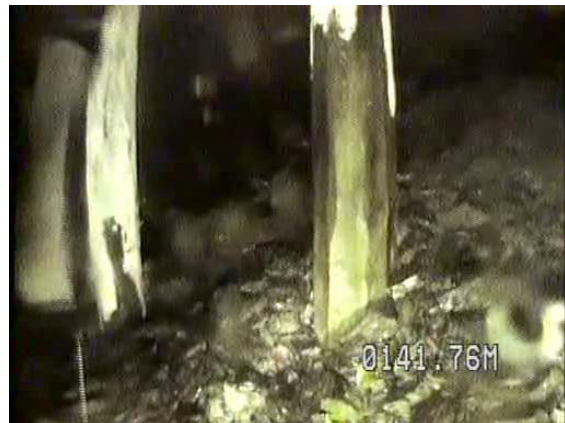
- The supports were still standing in one of the boreholes C-20. The supports had rocks and rubble around them. The rest of the boreholes showed broken material and damage to the support system

A video camera was lowered into 15 boreholes of which 2 were in the rehabilitated area of the mine. Five of the 13 boreholes in the unexplored section of the mine were collapsed and one was filled with water. In 7 boreholes the camera was able to reach the bottom. Out of the 7 holes only hole C-20 showed roof support standing with some rubble (Figure 2.14).

Figure 2.14: Snapshot from borehole C-20

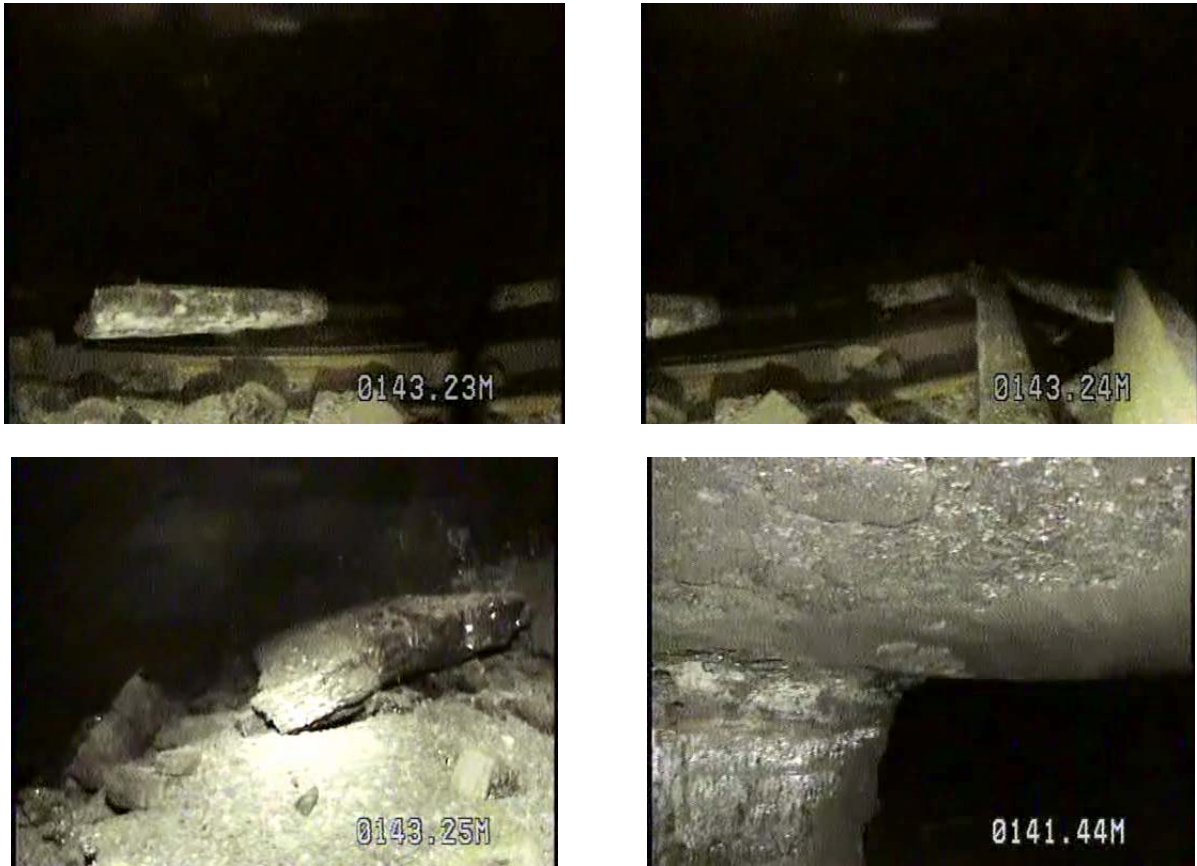
Borehole C-24 showed all timber down with some rubble on the floor and a relatively clean roof line (Figure 2.15).

Figure 2.15 Snapshot from borehole C-24

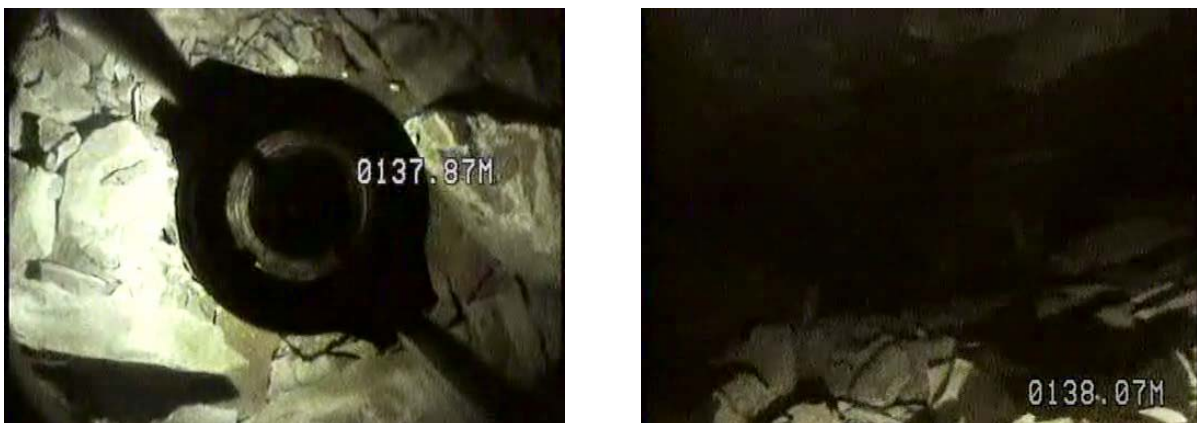
The rest of the holes showed no standing timber and had various degrees of caving and rubble at the bottom (Figure 2.16). The extent of the caving could not be assessed since the mine survey map was not provided. The mine floor elevation at the borehole location is needed to determine the vertical extent of the roof caving.

Figure 2.16 Snapshot from borehole C-5.

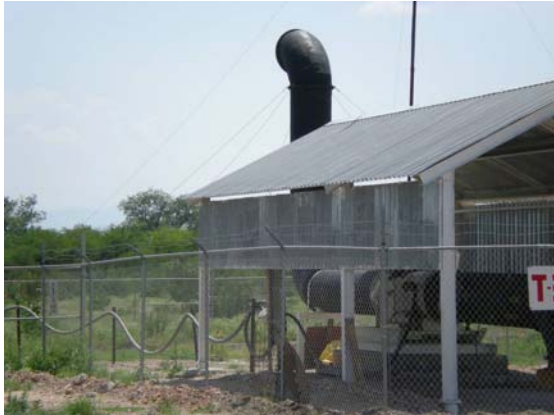
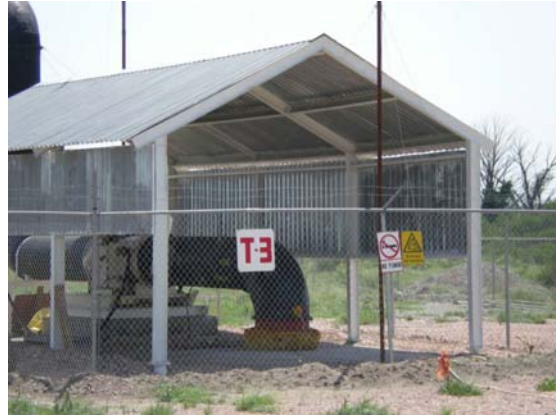
The bleeder borehole with fan is shown in Figure 3.1 and 3.2. The methane levels at this fan exceeded the explosive range (5%-15%) and the discharge airflow had to be diluted at the fan by opening the discharge pipe on the side to allow fresh air to dilute the gas prior to discharge to the atmosphere. The fan appeared to be properly grounded and the workmanship of the installation was good. In addition to the bleeder boreholes there are holes drilled for monitoring gasses underground like the one shown in Figure 3.3. De-gas hole #4 shown in Figures 3.4 and 3.5 was capped when the panel visited the site.

Figure 3.1 Bleeder borehole fan.

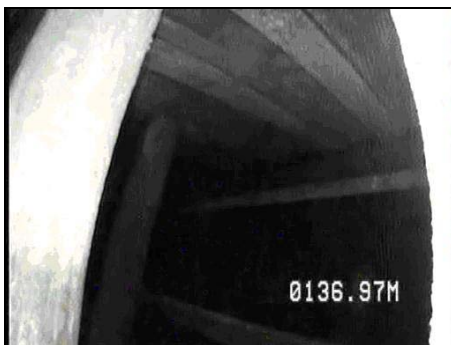
**Figure 1:** Borehole DG-5, Video 1 - The mine void observed through the borehole revealed that the rehabilitated area is holding up. (Dry conditions.)

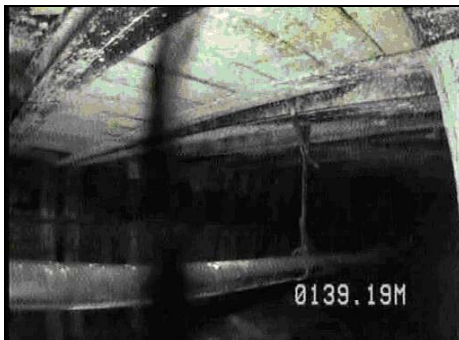
**Figure 2:** Borehole DG-7, Video 2 - The mine void observed through the borehole revealed that the rehabilitation area is holding up. *(Dry conditions)*

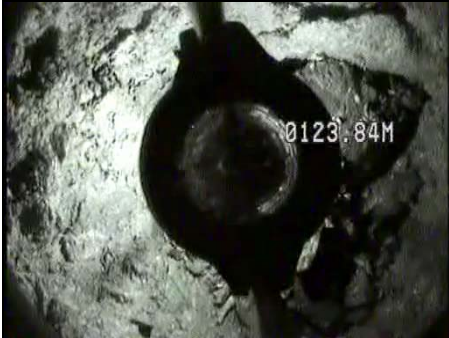
**Figure 3:** Borehole C-6, Video 3 - Hole is closed off at a depth of 124 meters.

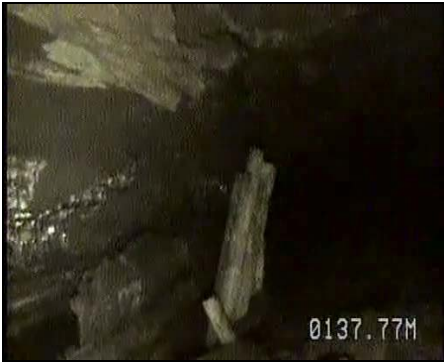
**Figure 4:** Borehole C-5, Video 4  
- The mine void observed through the borehole revealed the presence of a roof fall and related debris.

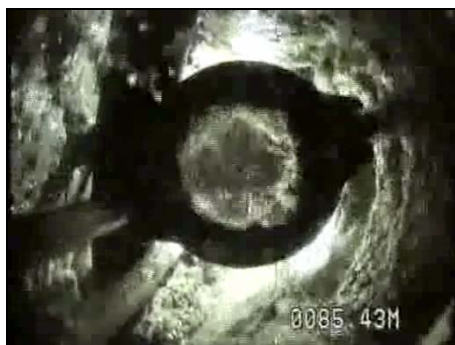
**Figure 5:** Borehole M-7, Video 5 -  
The hole is blocked by debris at a depth of 85.43 meters.

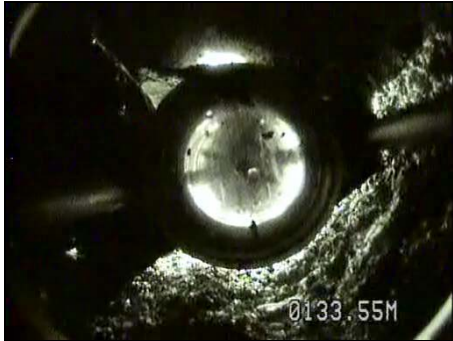
**Figure 6: Borehole C-23, Video 6**  
- Loose rock at 133.62 meters almost trapped the video unit in this hole. The mine void could not be reached and observed through this borehole.

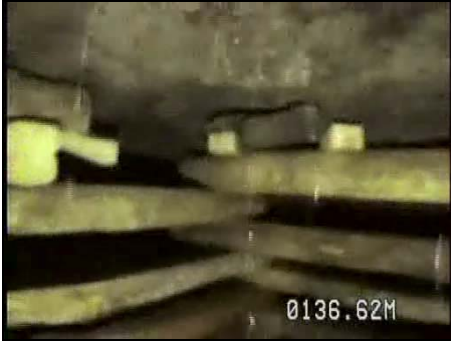
**Figure 8:** Borehole M-8, Video 8 - Hole is located within a crib installed in the mine entry. The crib appeared to be intact.

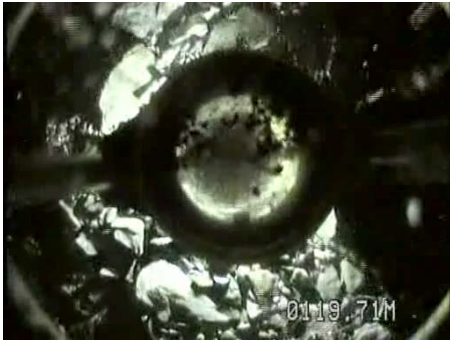
**Figure 9:** Borehole C-10, Video 9 - Hole collapsed at a depth of 119.0 meters.

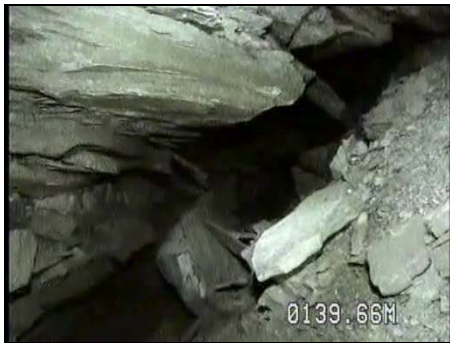
**Figure 10:** Video 10 - Reached a void at a depth of 139.7 meters revealing a fall. (*Dry conditions*)

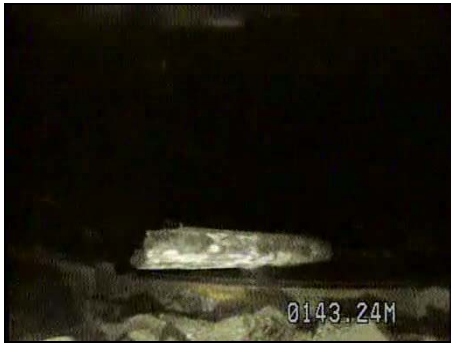
**Figure 11:** Borehole C-24, Video 11 – Rock on the floor of the mine void at the depth of 144 meters from the surface.

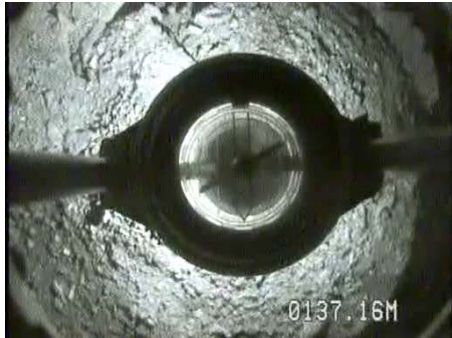
**Figure 12:** Borehole C-26, Video 12: Hole collapsed at a depth of 137 meters. (*Dry conditions*)

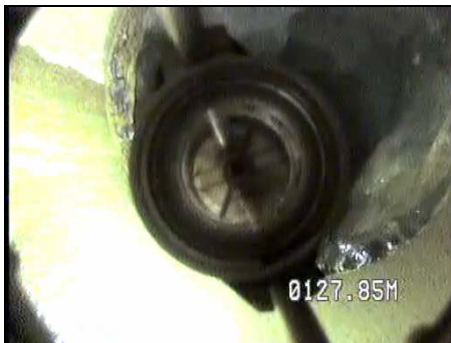
**Figure 15:** Borehole T-3, Video 15 – End of casing and one of several strata enlargements. Hole is offset in more than one location. *(Some water*

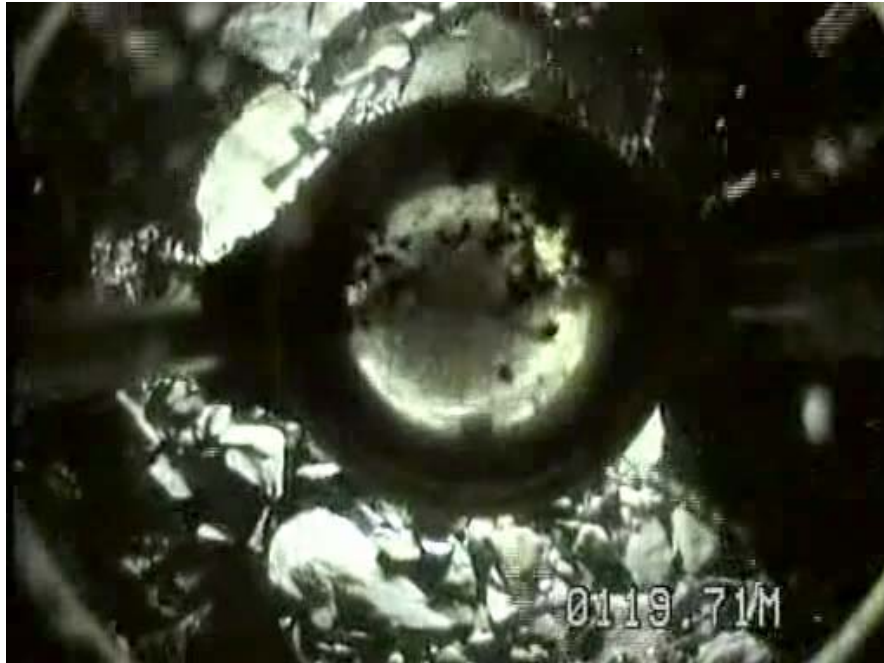
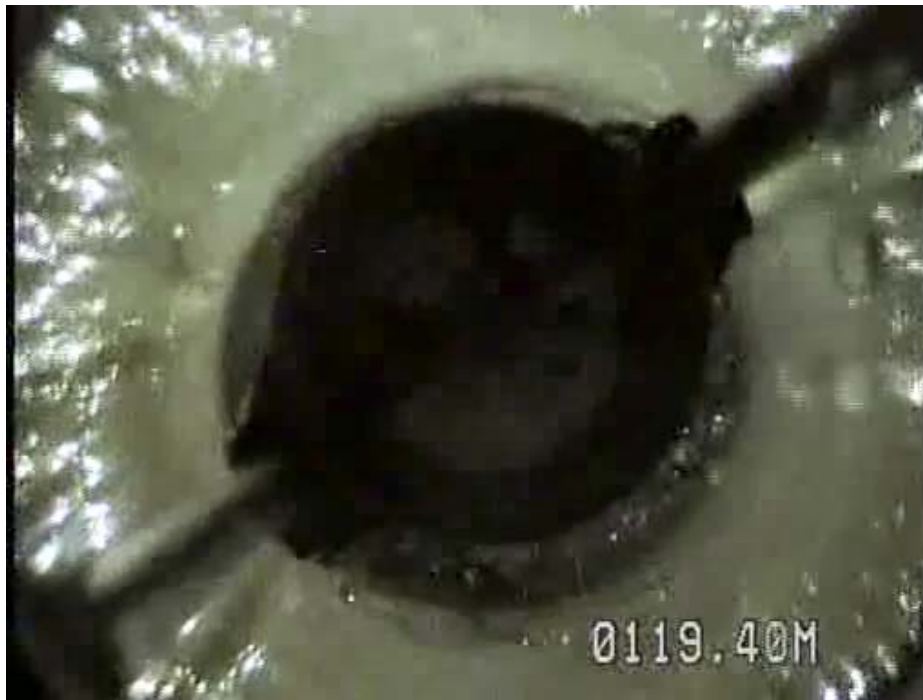
Figure 4.8a. Debris Blockage in C-10 as seen from 119.71 meters

Figure 4.8b. C-10 Blockage as seen from 119.4 meters

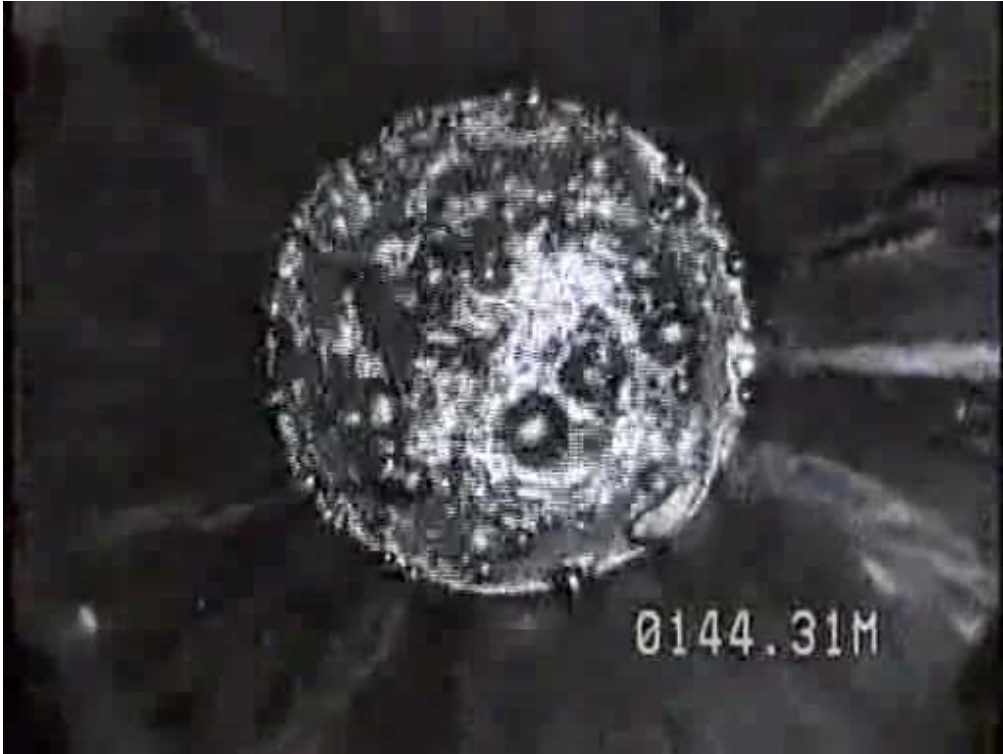
- The underground conditions in the video images show that in general the conditions inside the mine are unstable.
- In the C-11 borehole the water level is at 145m. The video shows Methane being liberated. The presence of water suggests a connection between C-15 and C-11 and that there are no temporary obstructions.

Figure 4.9. Water and gas bubbling at C-11

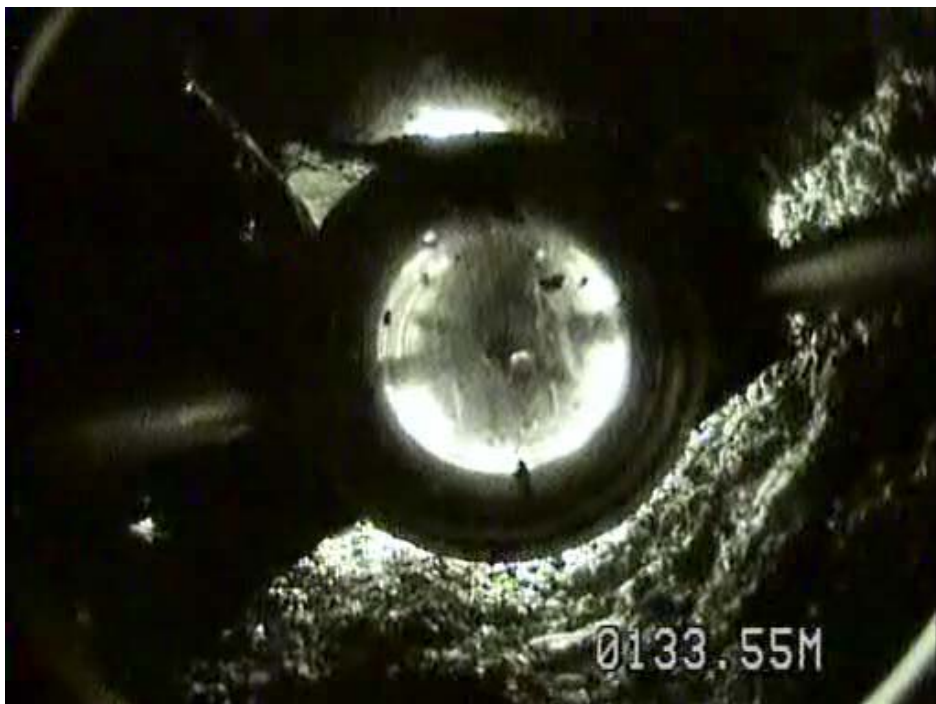
Figure 4.10. C-23 Obstructed borehole at 133 meters

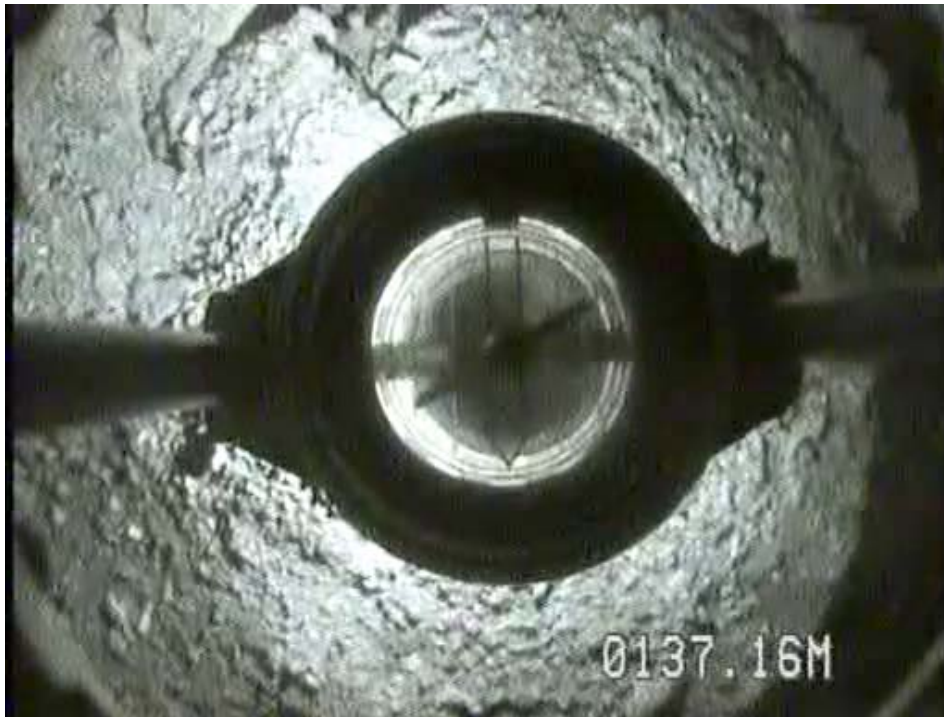
Figure 4.11. C-26 Obstructed borehole at 137 Meters

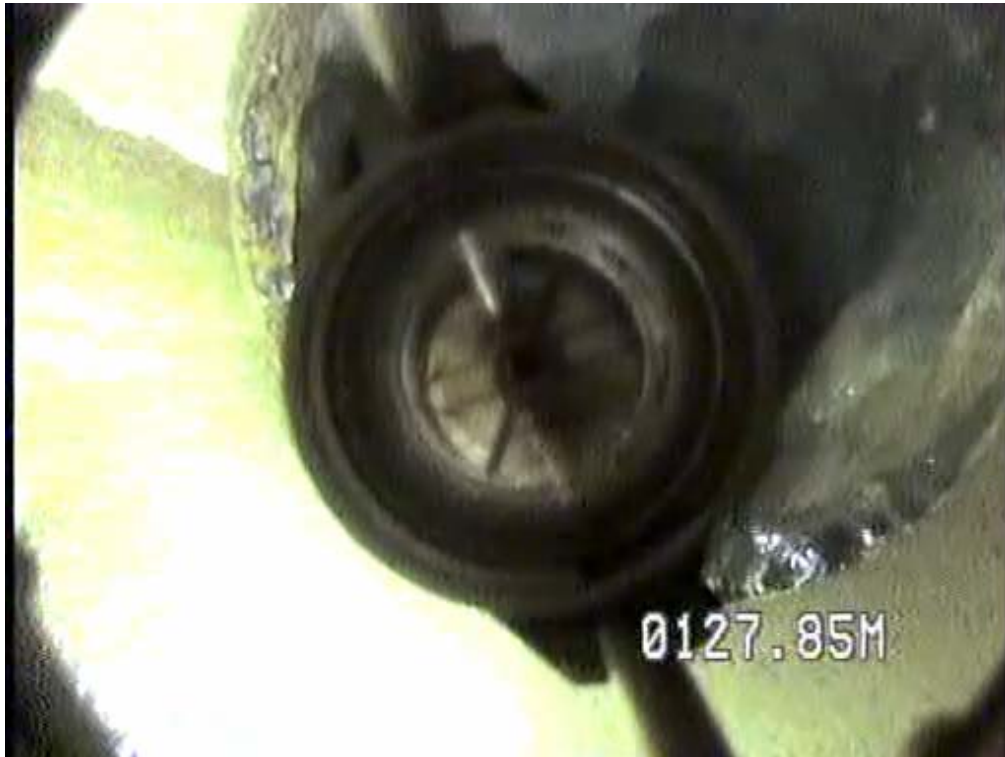
Figure 4.13. Offset in T-3

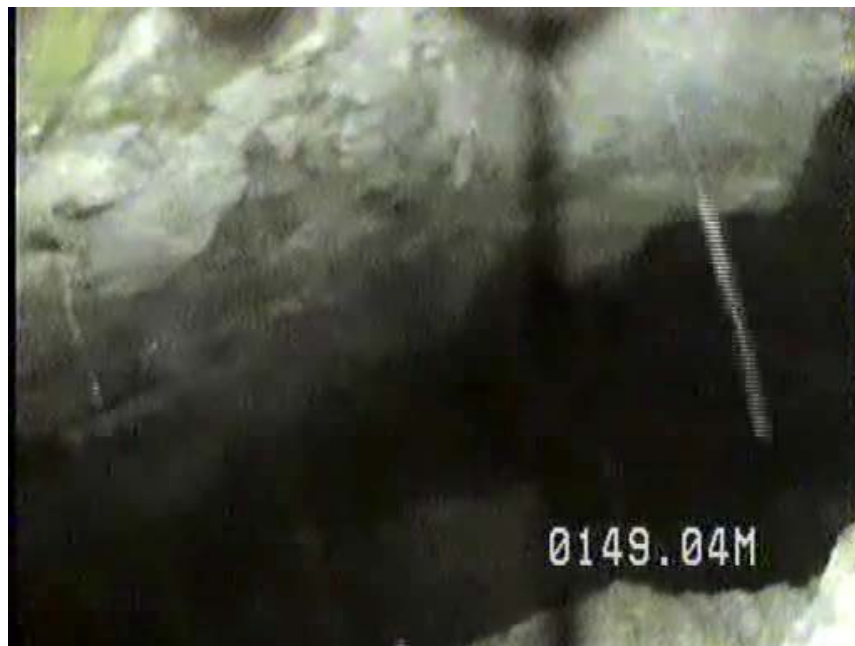
Figure 4.14. Rock Fall evidence in T-3

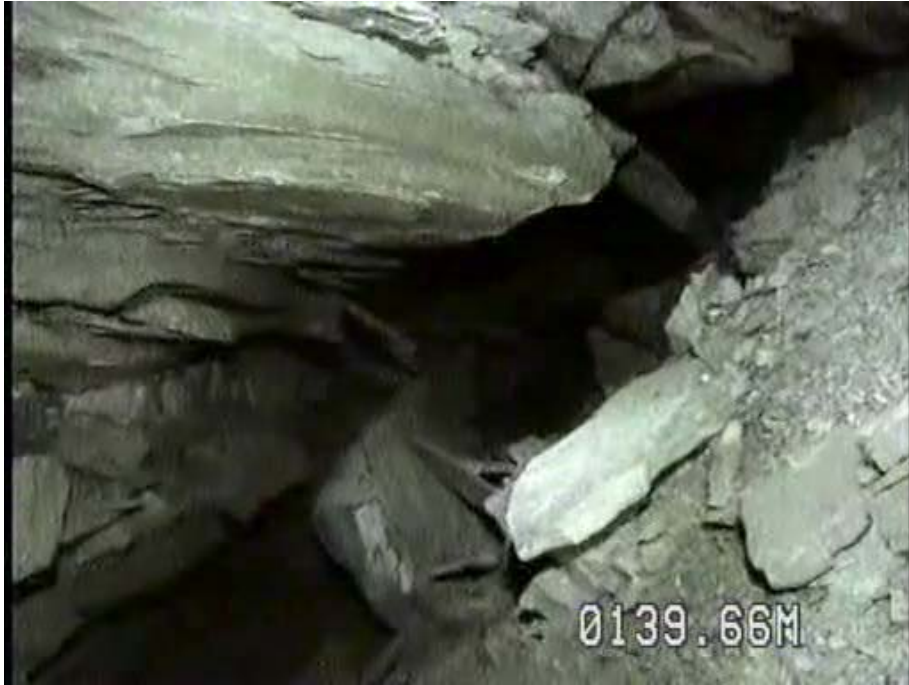
Figure 4.15. Degas Hole 11 Obstructed by rock fall at 139 Meters

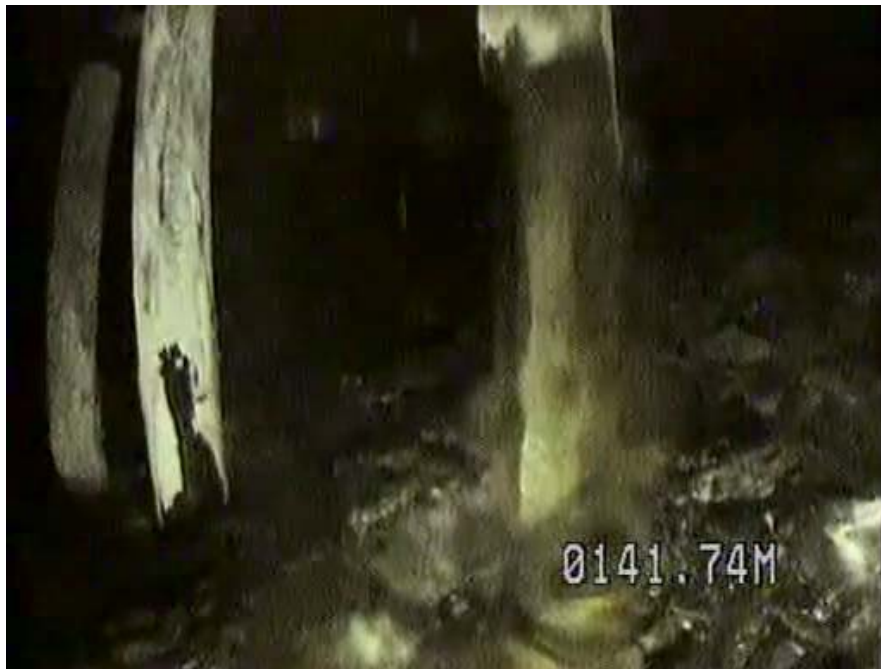
Figure 4.16. Borehole C-20 support posts still standing

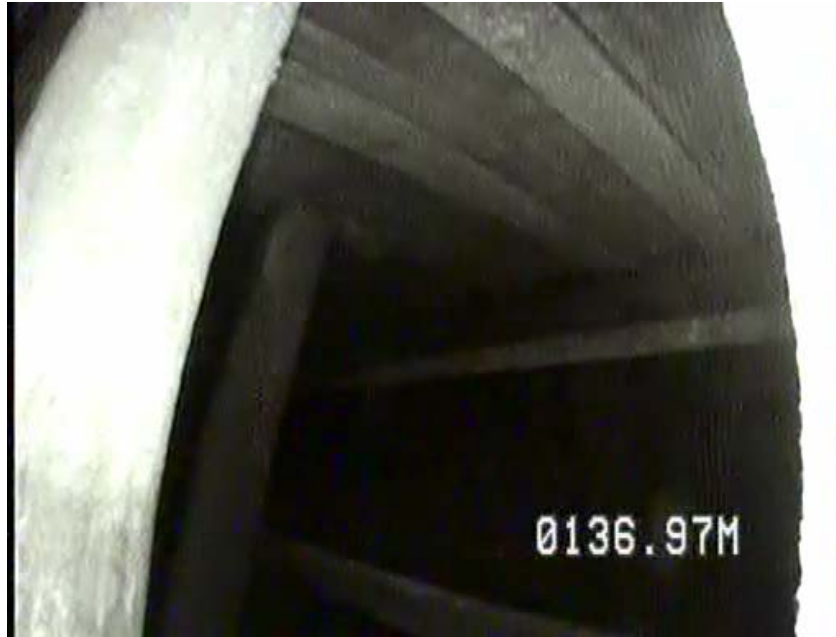
Figure 4.17 De-gas 5 Hole intact support structure

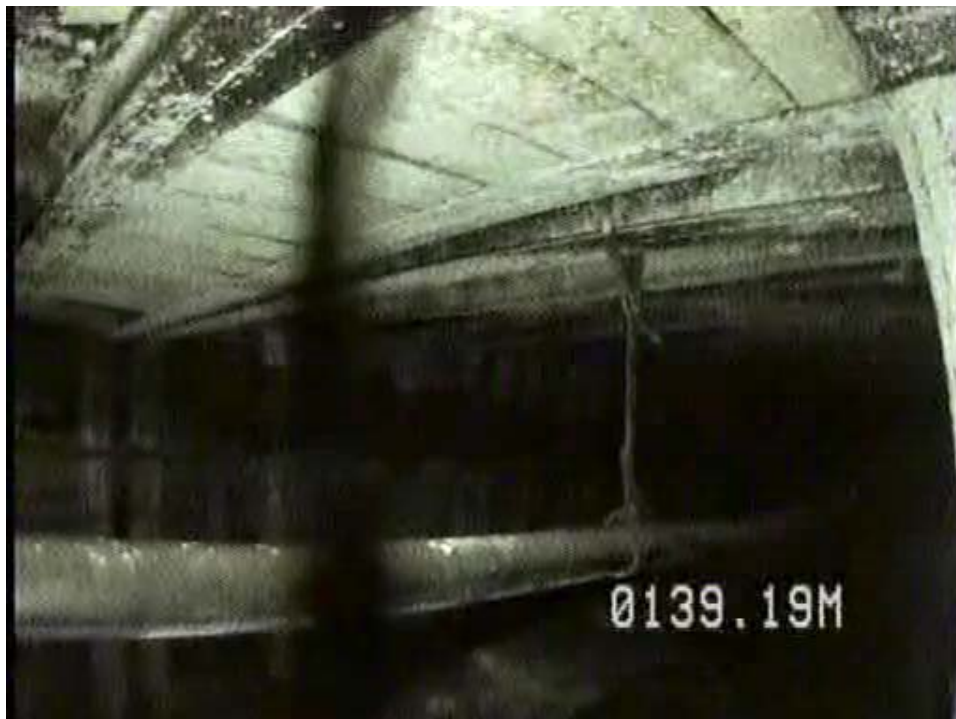
Figure 4.18. De-gas 7 Shows rehabilitate structure still intact

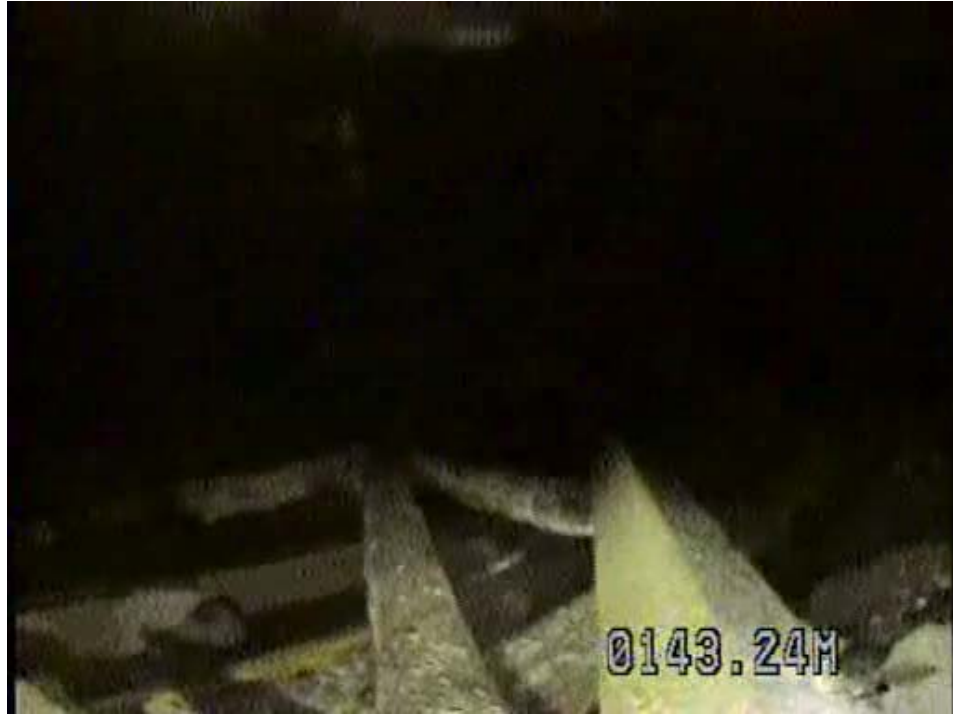
Figure 4.19. C-24 materials on the floor

Figure 4.20. C-24 materials on the floor

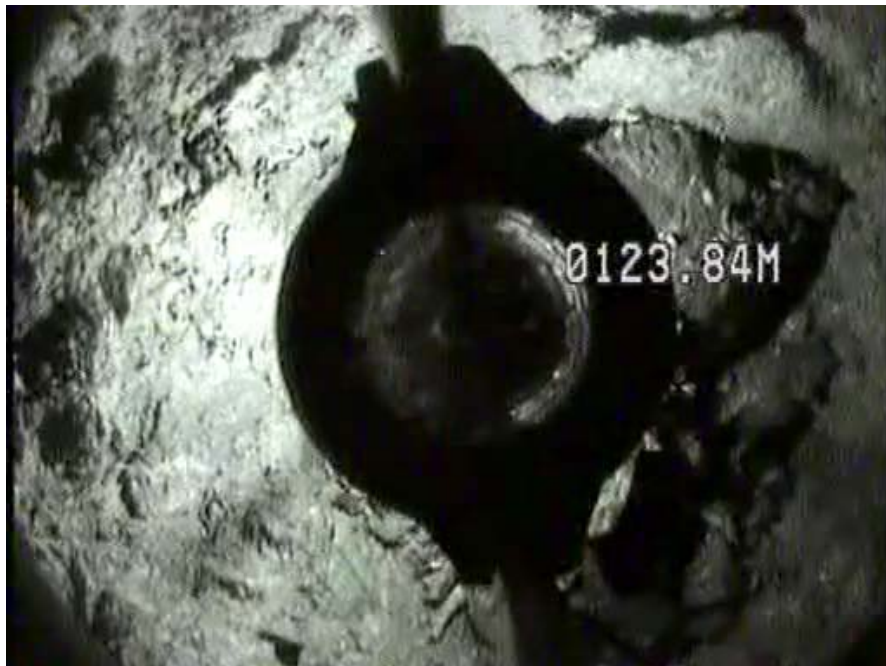
Figure 4.22. C-6 Obstructed at 124 Meters

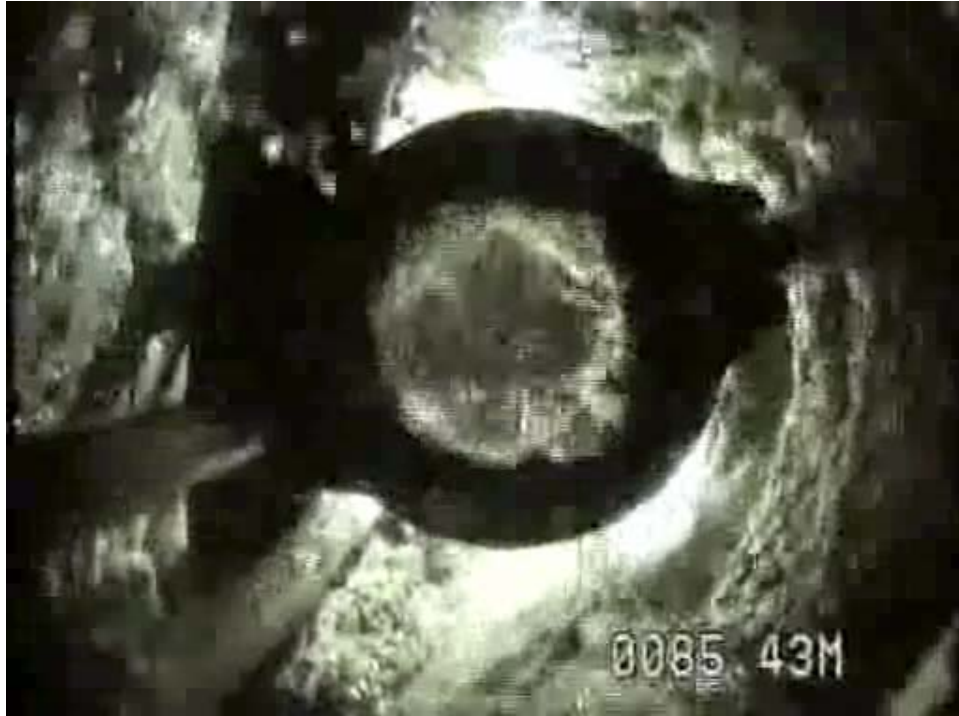
Figure 4.23. Running water in Obstructed M-7 at 85 meters
