# **Condiciones de seguridad e higiene que prevalecen en la Mina 8 Unidad Pasta de Conchos**

## **Informe**

**Del estudio realizado por el Panel Internacional de  
Expertos en Seguridad en Minas del  
Foro Consultivo Científico y Tecnológico, A.C.**

Octubre 5, 2007

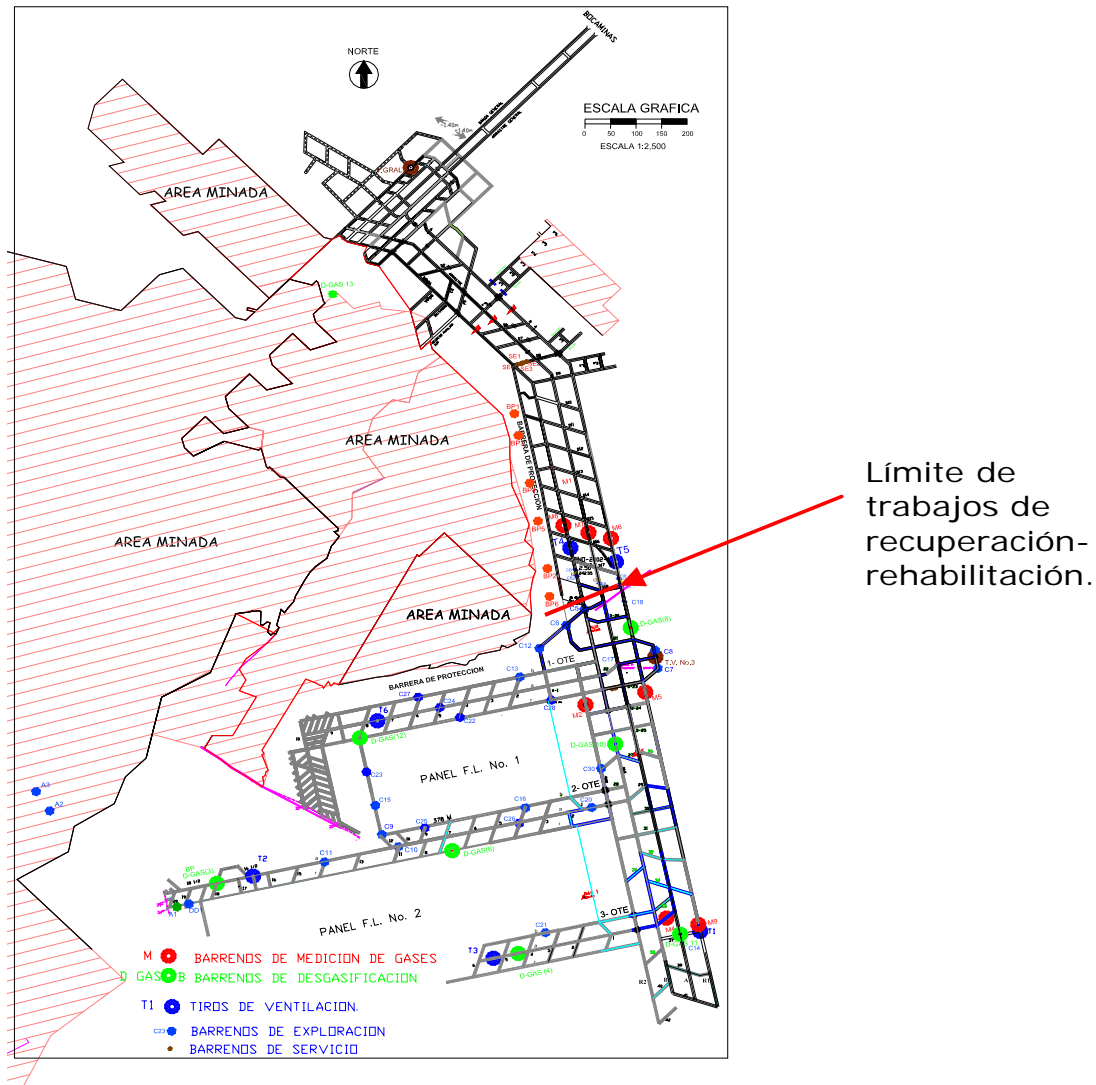
According to company reports submitted to the Secretaria del Trabajo y Prevision Social (STPS) Table 1.1 describes the level of effort that was undertaken up to April 3rd 2007 when recovery efforts were halted due to safety concerns. Figure 1.1 shows the areas that were rehabilitated during the recovery efforts in 2006-2007.

Figure 1.1: General Plan of the mine showing the areas where recovery efforts stopped

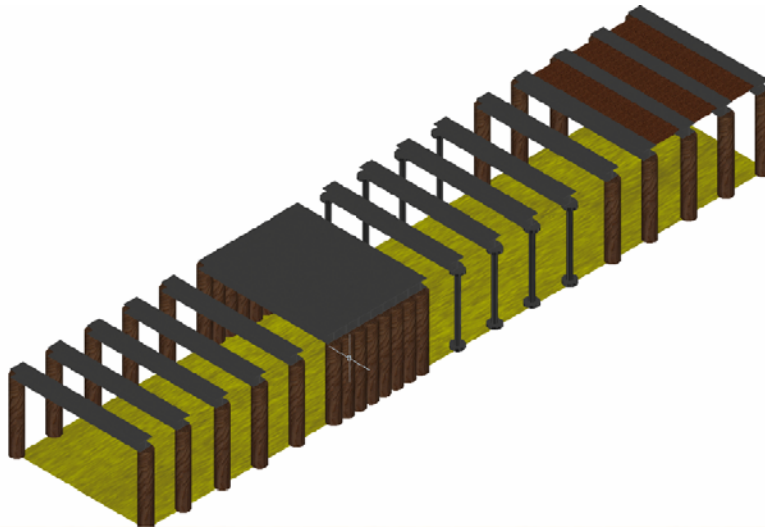
At the Pasta de Conchos mine the 5.2 m wide by 2.4 m high entries are developed with a continuous miner that takes 12 alternating 2.5 m wide and 0.5 m deep cuts to advance 3 m before roof supports are installed. A combination of timber-steel set and steel set are used for roof support. Figure 2.2 depicts the various roof support configurations that are used at the mine. The selection of support system is based on the roof rock conditions. Steel beams of 5.5 m length are used to bridge the intersection at cross-cuts; there is no information whether additional vertical supports is used at the four corners of the intersection. In areas with very poor roof condition, 0.25 m of coal is left as an immediate roof to allow for a timely roof support installation. In normal conditions the timber-steel sets are spaced 0.7 m apart.

Figure 2.2 Support system used at the Pasta de Conchos mine

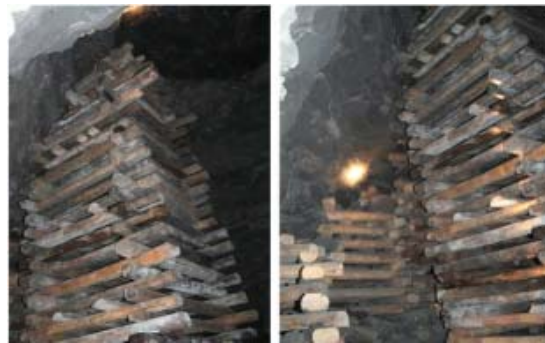
At cross-cut intersections, cavings as great as 13 m high and 15 m wide have been reported (Figure 2.4). The caved areas were rehabilitated with the use of cribbing above timber-steel sets (Figure 2.5). Cribs are designed to support vertical loads, but can collapse when lateral loads are applied. The height of the cribbing used to rehabilitate the caved areas would be extremely unstable in the presence of lateral ground movements (Figure 2.6).

Figure 2.5 Cribbing to support caved area.

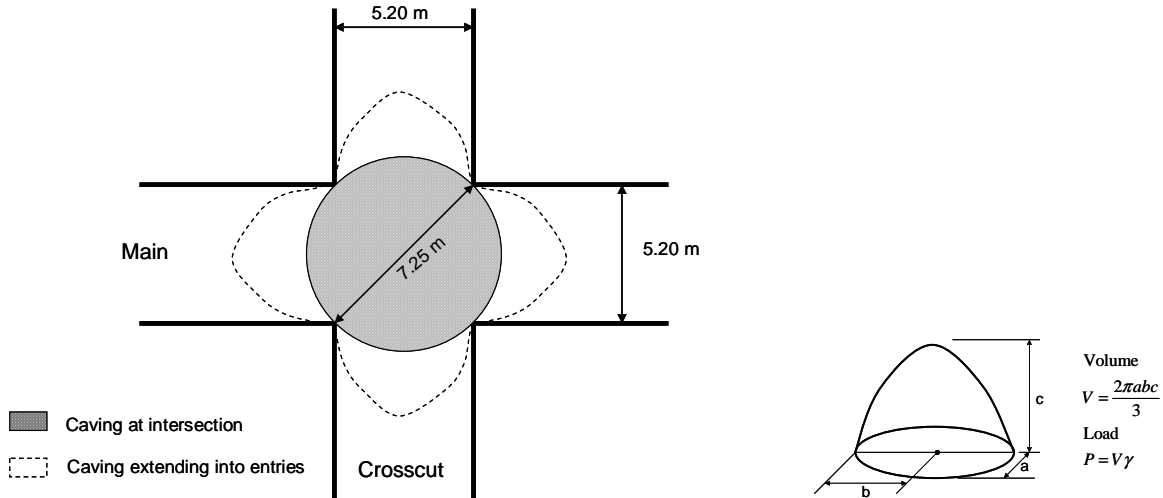
At the intersections (Figure 2.9) the shape of the caving can be assumed to be ellipsoid with a diameter of 7.25 m and a height ranging from 3.6 to 5.76 m. The load on the roof support is estimated to be in the range of 297 to 476 ton. This load would be distributed to the vertical support members at the four corners of the intersection.

Figure 2.9 Geometry of caving at intersection.

Information on the type of vertical support used at the four corners of the intersection is not available to assess its performance.

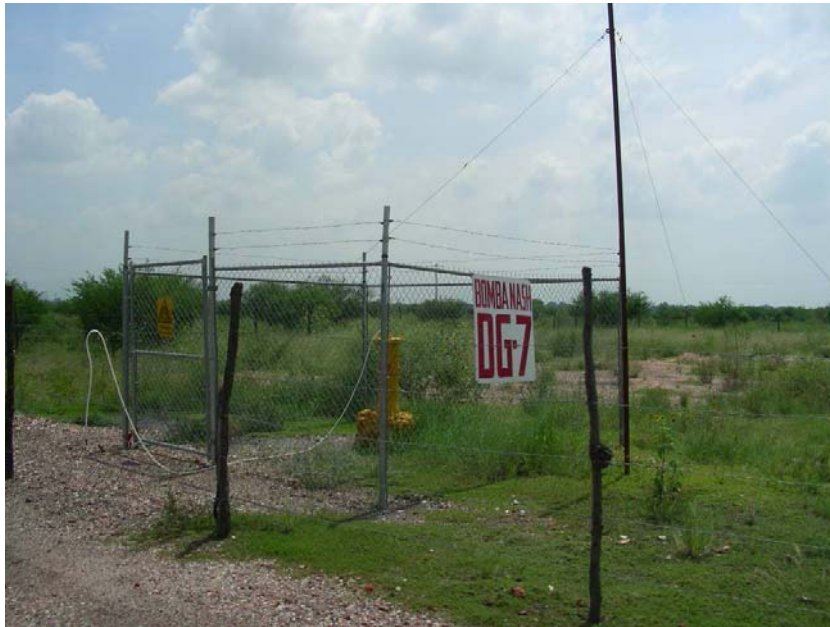
The bleeder borehole with fan is shown in Figure 3.1 and 3.2. The methane levels at this fan exceeded the explosive range (5%-15%) and the discharge airflow had to be diluted at the fan by opening the discharge pipe on the side to allow fresh air to dilute the gas prior to discharge to the atmosphere. The fan appeared to be properly grounded and the workmanship of the installation was good. In addition to the bleeder boreholes there are holes drilled for monitoring gasses underground like the one shown in Figure 3.3. De-gas hole #4 shown in Figures 3.4 and 3.5 was capped when the panel visited the site.

Figure 3.3 Monitoring drill hole.

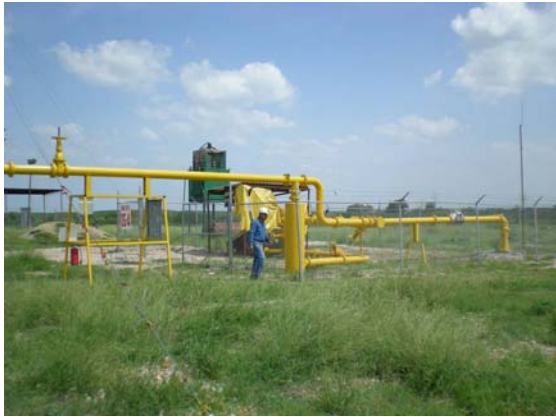
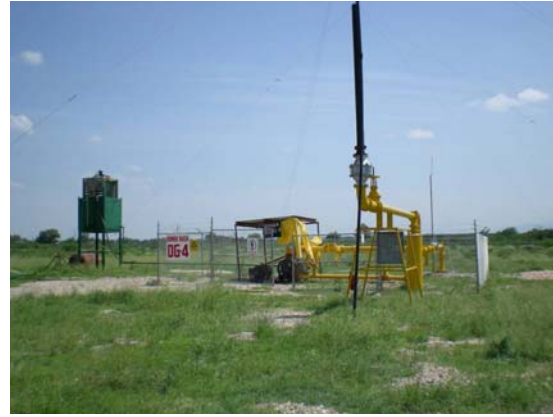
Figure 3.4 De-gas hole 4

Figure 3.5 De-gas hole 4

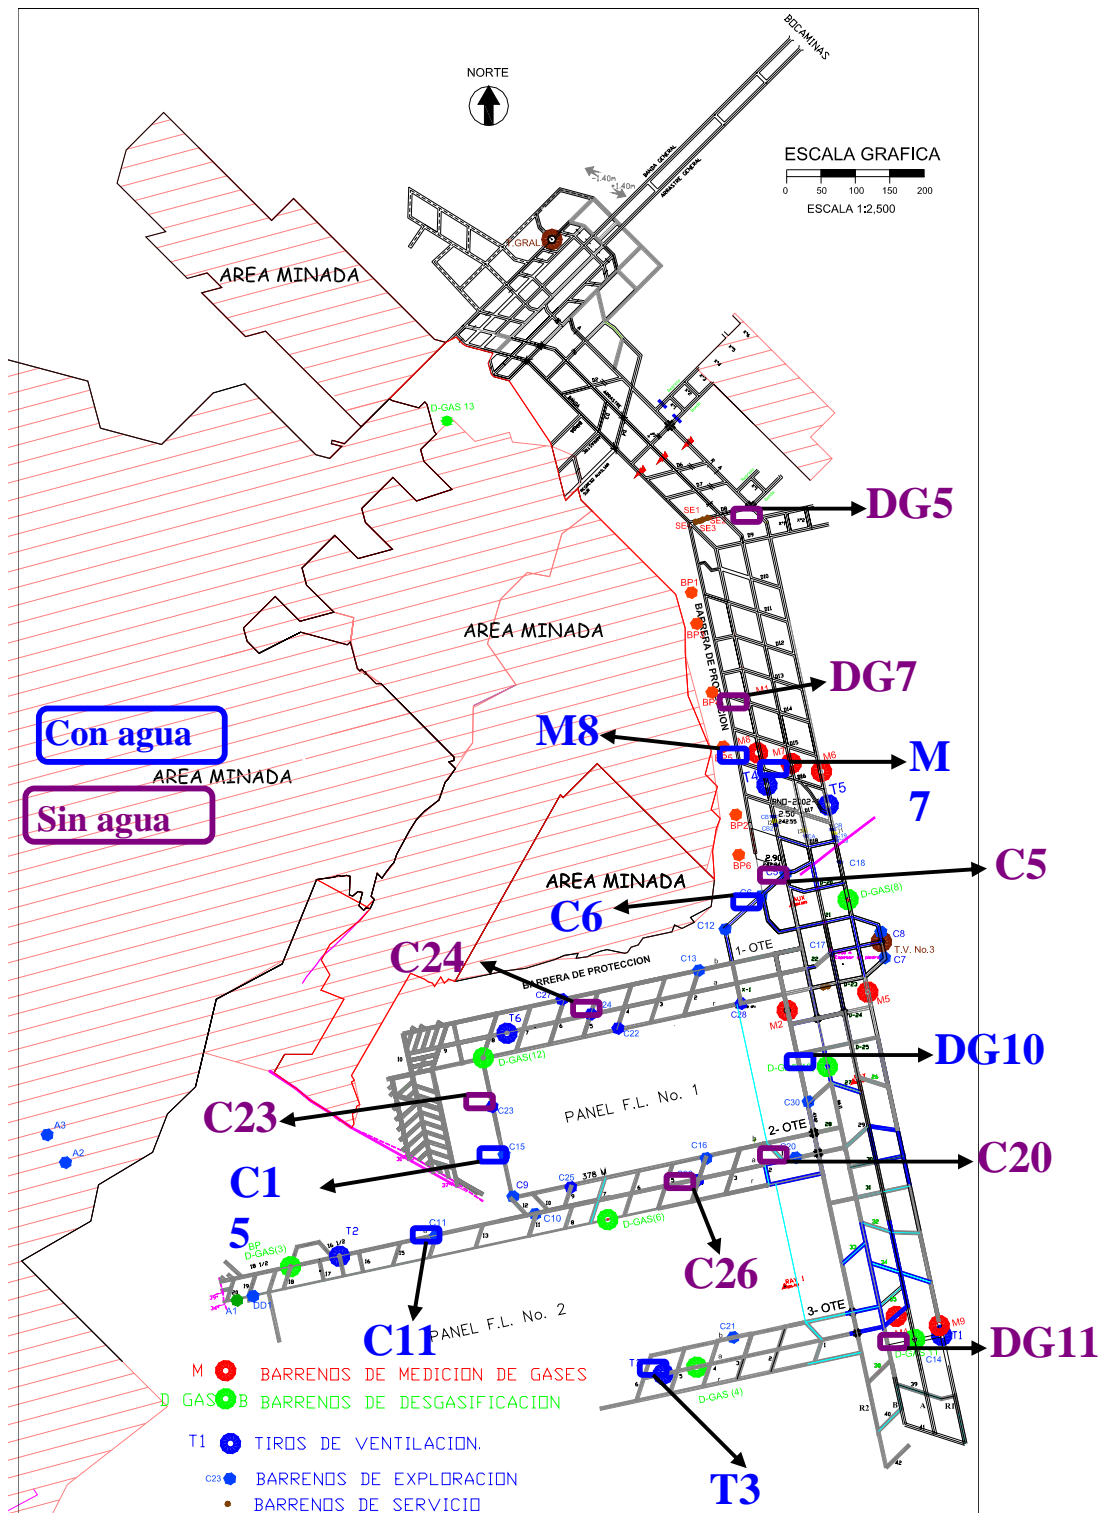
Marshall Miller & Associates, video-logged 15 holes and this information provided some insight regarding the mining water conditions. Boreholes with wet conditions are indicated in blue in Figure 4.2, only boreholes C-11 and C-15 show flooded mine conditions as noted in Table 4.1.

The bore hole C-15 at the longwall panel face area indicated the water level at approximately 145 m which is about half the height of the opening. The bore hole c-11 located at the tail gate indicated the water is in the bore hole at depth of approximately 145m based on the topography elevation inferred from core logs (Figure 4.1) and clearly shown the gas liberation (most likely Methane). One positive conclusion is the water level demonstrated that there is communication between the two holes and there is no temporary dams existing which may cause additional safety concerns. Snapshots of the borehole video logging for water analysis purposes are given in Appendix E.

Figure 4.2 Borehole video locations

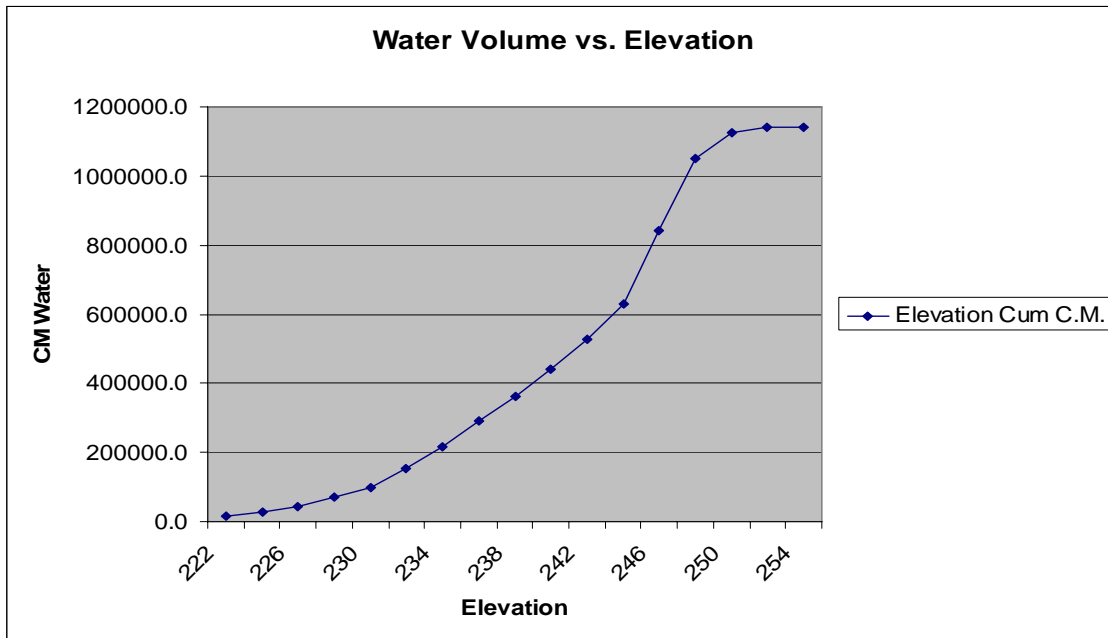
Figure 4.3 contains a fence diagram showing the way the estimate was calculated using gridded surfaces. A surface was created for each water level at 2-meter increments. The mine outline and pillar works were then used to cut across the surfaces. The results are shown (Figure 4.4) in the form of a stage-storage curve based on water elevations. This is a high-side estimate that can be pro-rated when the total amount of mined volume is known. Water volume by elevation is listed in Table 4.2. The quantities indicated were derived from Carlson Software's volumetric routines.

Figure 4.4 Water volume (m<sup>3</sup>) versus Mine Elevation (meters)

The water build-up since the pumps were shut down will be a function of the elevation of the water at the beginning of the shut-down period. As can be seen in the stage-storage curve the capacity changes dramatically with the elevation in the mine. With good flow and open areas there would be little build-up if the water was already at the 232 elevation for example. This is where piezometer readings would be essential in determining the extent of the drainage volume.

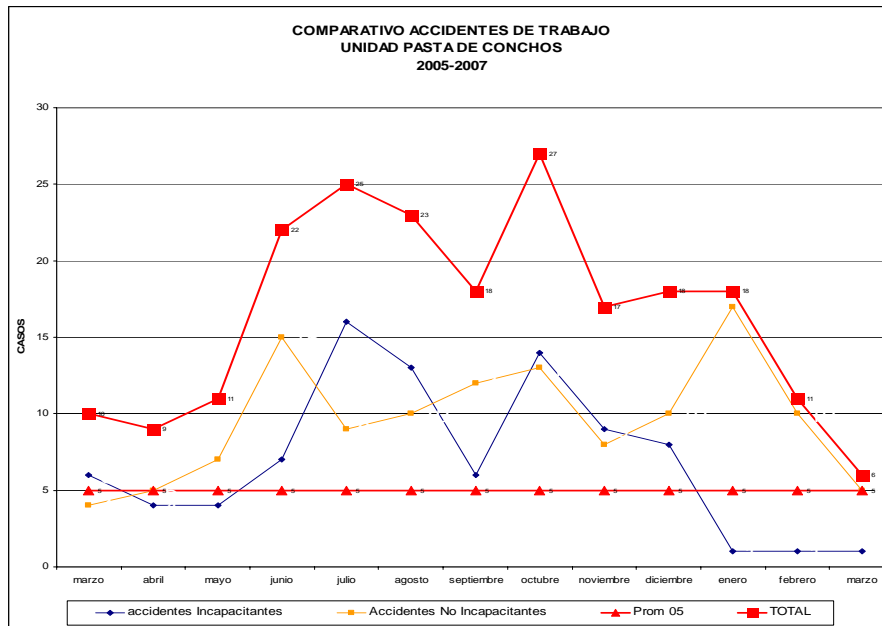
The Pasta de Conchos mine safety data that was provided to the team includes the graph shown in Figure 7.1. This graph shows the number of incidents per month that occurred between March 2006 and March 2007.

Table 7.1 summarizes the data depicted in Figure 7.1. This graph displays the average number of incidents per month during 2005. The graph also shows that the number of accidents occurring during the recovery averaged 24 incidents per month for the 13 months. This is almost five times the monthly number of accidents during the 2005 routine operations at the mine.

Figure 7.1: Comparison of the number of accidents per month to past year (2005) performance

- Accident Records:** The lack of comparable incident rate data from the Mexican mining industry prevents the team from fully evaluating the level of increased safety risk associated with the recovery operations between February 2006 and April 2007. The limited analysis that was possible shows a safety incident rate during recovery to be approximately five times the average incident rate during normal operations at the mine during 2005. This shows a much higher than normal risk associated with the recovery operations.

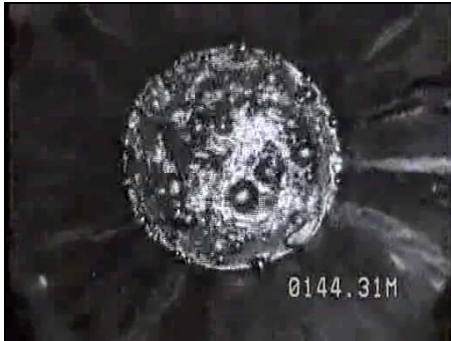
The westernmost borehole investigated by MM&A was Borehole C-11. This borehole is located within the 2-O TE section, nearest to the location of a continuous miner section. It does not intercept a rehabilitated portion of the underground mine. The total depth to mine roof was reported by the mine owner to be 154.0 meters.

**Figure 13:** Borehole C-11, Video 13 - Water with gas bubbles at a depth of 145 meters from the surface.

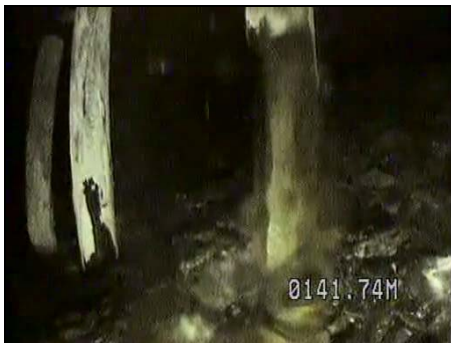
**Figure 14:** Borehole C-20, Video 14 - Interior view of the mine void at a depth of 141.74 meters revealing standing roof support timbers, rubble, and some water.

Borehole C-20 is located within the center entry of the 2-O TE section, near the "mains." It does not penetrate a rehabilitated portion of the underground mine. The total depth to the mine roof of Borehole C-20 was reported by the mine owner to be 140.0 meters

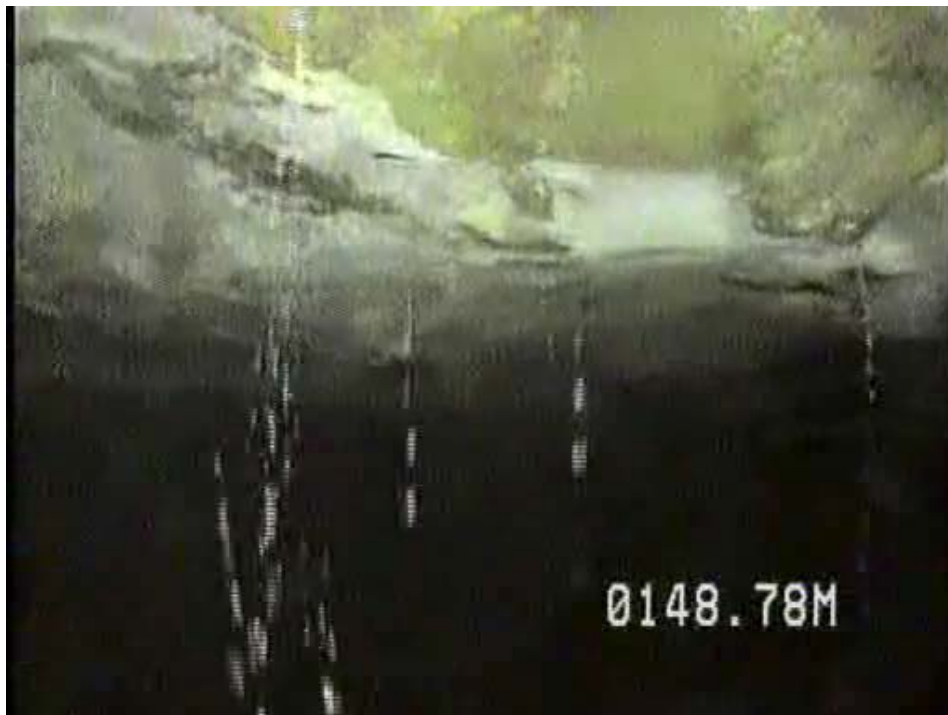
Figure 4.12. T-3 Ventilation intake hole

Figure 4.12 shows T-3, a ventilation intake hole. The hole has shifted significantly since it was drilled.

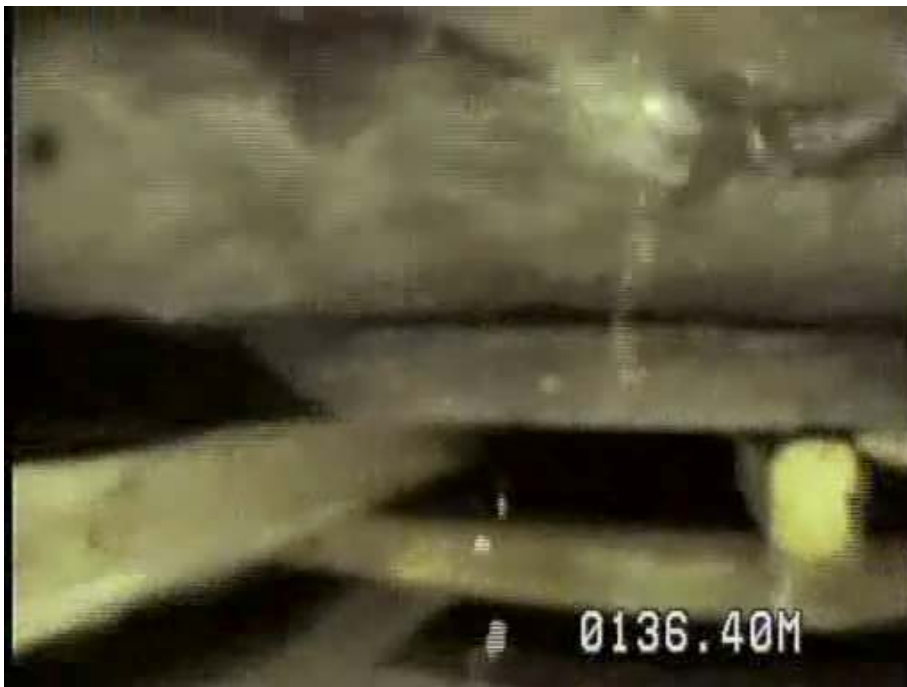
Figure 4.24. M-8 Inside the cribbing

The M-8 hole shown in Figure 4.24 was located inside a crib. The crib appears to be intact. There is some inflow of water in this hole

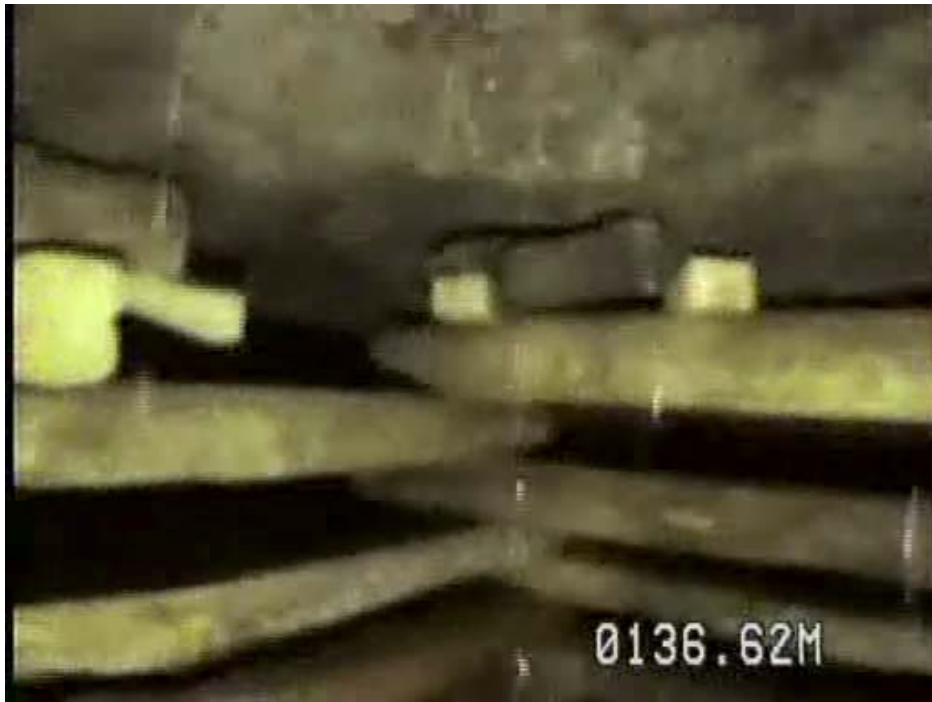
Figure 4.25. Another view of M-8 cribbing

Another photo of M-8 shows the crib in place in Figure 4.25.
